Review of incidents at Hazardous Waste Management Facilities

November 2007 Version 1

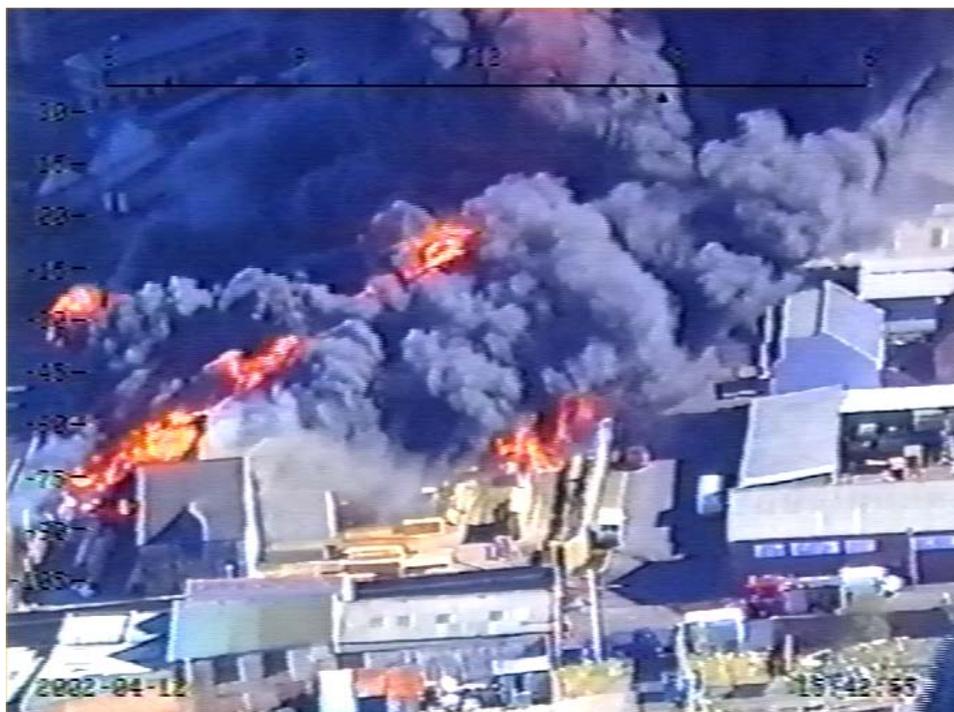
Incident 8	
Date of incident	12 April 2002
Operator Name (at time of incident)	Distillex Ltd
Site Address	East Percy Street North Shields North Tyneside

A major fire developed on the site after an IBC containing flammable substances was cut for disposal using an angle grinder. The angle grinder produced a large number of sparks that ignited the contents of the IBC. Despite attempts by site operatives to tackle the fire, it spread quickly through the site.

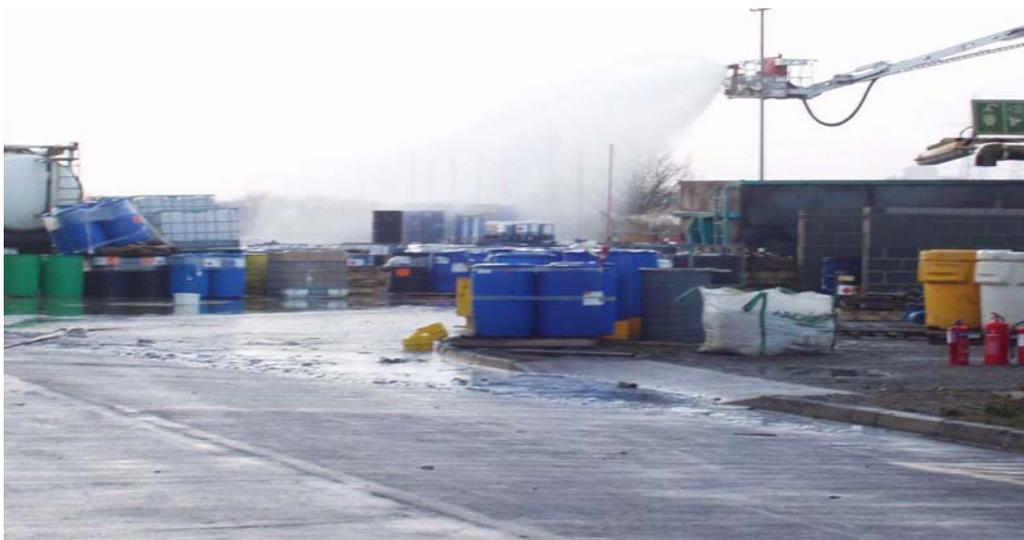
A water curtain was set up to cool the fire and thermal imaging equipment used to monitor the heat of the fire at its seat, the 160l drum. After cooling for an hour the fire brigade stood the incident down as temperatures were returning to normal. At 21:00 a large explosion occurred in the drum storage area and burning spools of Li/Cu was showered over the entire site causing numerous secondary fires. The local residents at Seaton Carew were warned to close all doors and windows and stay inside as smoke was being blown in the Towns direction. The smoke situation was further exasperated by the secondary fires in the tank farm and flammable waste storage area. The main "non-haz" tanks were made of glass reinforced resin which was burning rapidly and giving off acrid toxic fumes. Five firemen were treated for smoke inhalation with two being admitted to hospital for monitoring overnight.

Throughout the incident numerous flammable liquids in storage exploded, ranging from 25l to 205l drums of solvents. Due to fact that an inventory of materials on the site could not be provided the Agency advised the fire brigade of the waste streams allowed under the licence and the fire was fought with the aim of containing it and preventing it spreading to other areas. At its highest 12 fire engines and 60 firemen were fighting the blaze. By 09:00 the following day the situation was under control and all secondary fires were out, with only the water monitor continuing to cool the drummed waste bays.

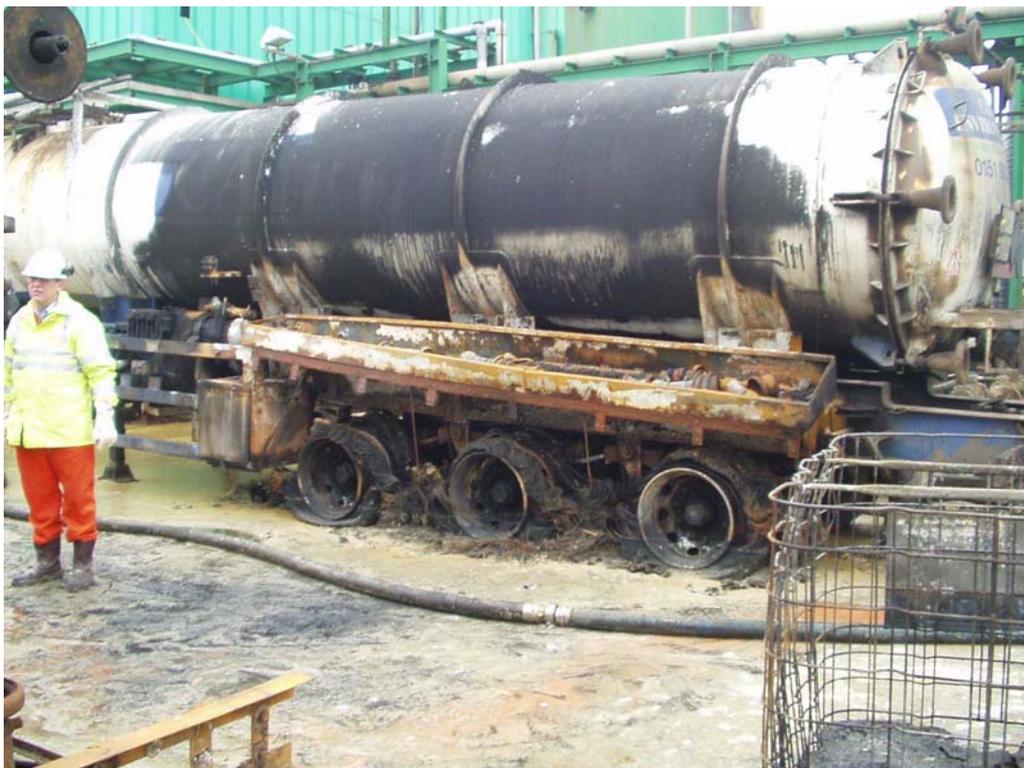
Waste lithium/copper strips from the manufacture of dry cell batteries were accepted onto the site contrary to the site licence which specifically excludes both alkaline earth metals and water reactives. The Li/Cu strip is used as the anode in dry cell batteries of the type found in modern watches. The material is a two sided strip, about the same width as a 35mm camera film, and is wound onto metal spools similar in appearance to cine films reels and about 30cm in diameter. As virgin product it is hermetically sealed in a dry room within foil packets and further sealed within 160l UN approved containers and shipped from the manufactures as a UN packing group II product. The material that caught fire was no longer sealed. It was wound back around the spool in some cases, and simply scrunched up in others, before being placed in waste 205l and 160l drums. The material had, according to the paperwork, been packed by a Shanks chemist and the waste producer paid for this service.

The failure to correctly store and package the material led to a reaction, most likely with moisture present within the waste drums. This in turn lead to a metal fire and the resulting explosions.

A very serious situation was worsened by the lack of a site inventory. This lead to the fire brigade having to fight the fire defensively rather than being able to attack points selectively to prevent its spread. In effect the fire brigade had to drench the site and let the fire burn itself out.
